**PISCATAQUA RIVER BASIN
DEERFIELD , NEW HAMPSHIRE**

FREESES POND DAM

NH - 00472

**PHASE I INSPECTION REPORT
NATIONAL DAM INSPECTION PROGRAM**

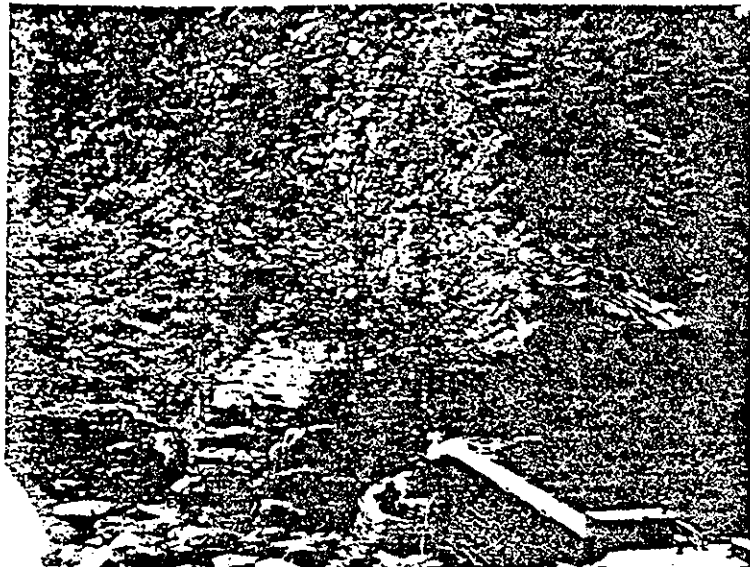
VIEW OF DAM FROM
LT EMBANKMENT

NOTE: BREACH + TREE GRO

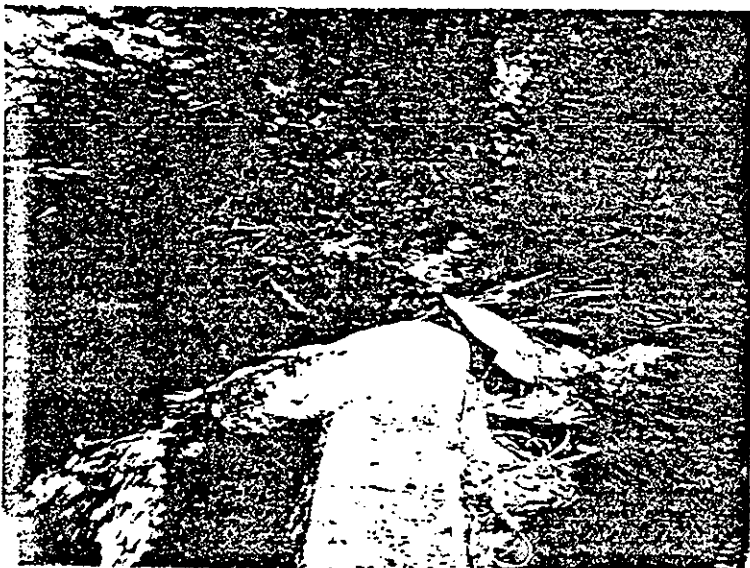
VIEW OF BREACH FROM
SPILLWAY

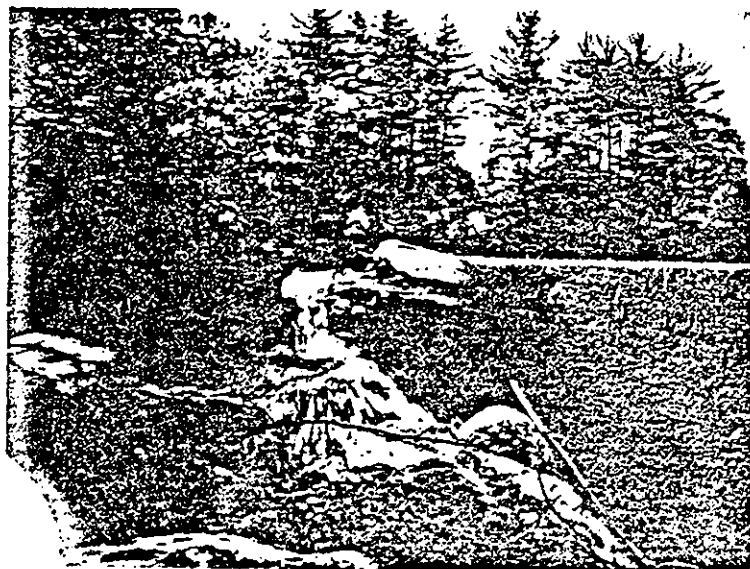
VIEW OF BREACH
FROM DOWNSTREAM

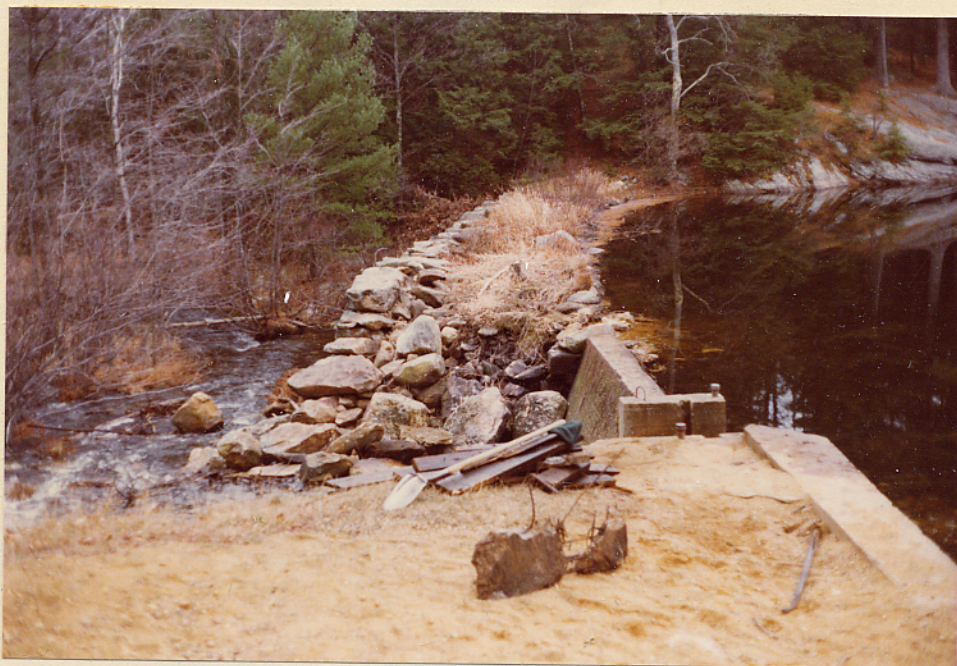
1
VIEW TO WEST ALONG DAM

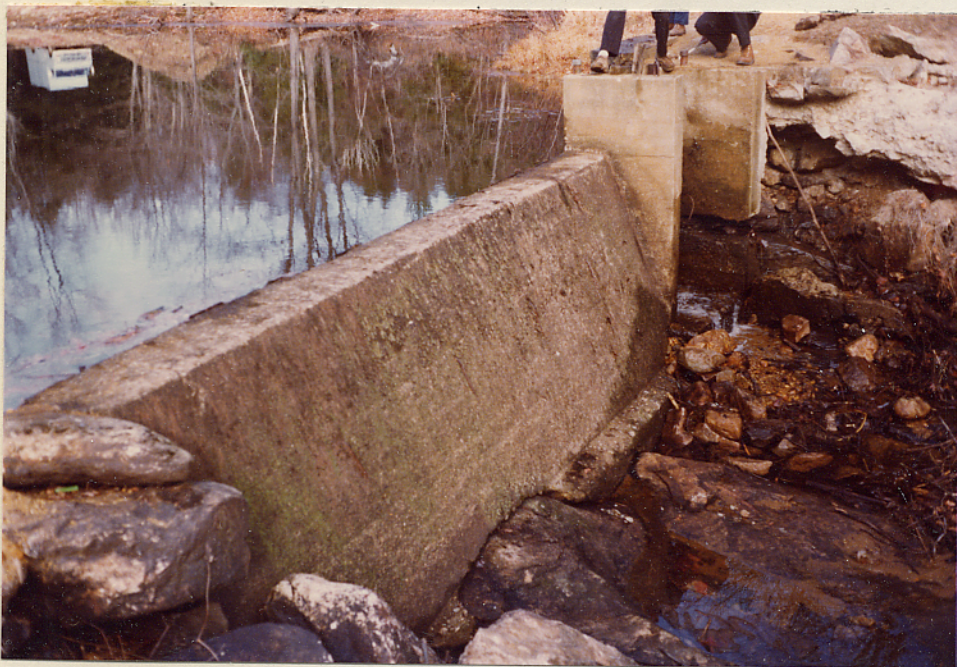
- (c) The spillway section of the dam appears to be in good structural condition (see Photograph #2). Minor leakage is occurring at the joint between the concrete and bedrock but appears insignificant.

- (d) The junction between the stop log outlet and the easterly embankment is in poor condition. The concrete training wall is spalled and eroded and erosion of the embankment has occurred (see Photograph #2).

The junction between the stop log outlet and the easterly embankment is in poor condition (see Photograph #2). In this area the concrete training wall is badly deteriorated and embankment materials have eroded. Seepage is occurring through the dam at this junction.

2
CONCRETE SPILLWAY AND STOP LOG STRUCTURE:
NOTE EROSION OF FAR ABUTMENT.

- (1) Repair the concrete training wall east of the outlet structure.
- (2) Repair or replace the stone masonry training wall west of the spillway.
- (3) Replace missing capstones and re-establish erosion protection for the embankment sections of the dam.
- (4) Repair or replace stop logs and put the controlled outlet into an operable condition.
- (5) Provide for 24 hour surveillance of the structure during anticipated high flow conditions.
- (6) Develop a formal warning system and implement its use in the event of an emergency.
- (7) Have the dam inspected by qualified engineers once every year.
- (8) Remove debris from the downstream channel.

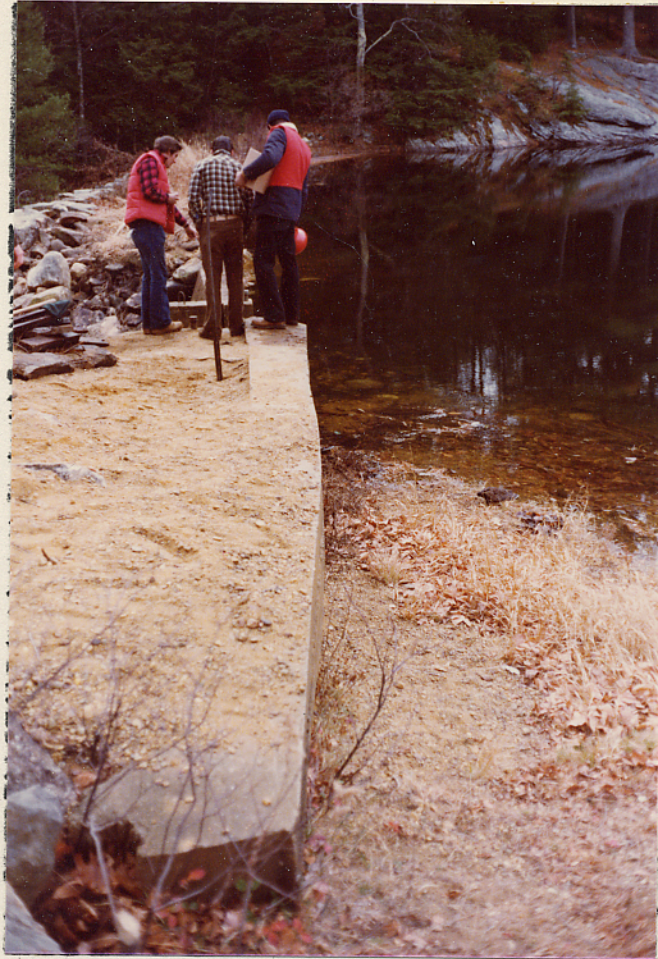
- (e) The easterly embankment section appears to be in fair condition. Substantial seepage is occurring into the upstream face of this section and out of the downstream face near the stop log outlet. Substantial erosion has occurred on the downstream face of this section. The concrete wingwall which forms the upstream face has cracked and appears to have undergone some settlement (see Photograph #3).

The easterly embankment section has an upstream concrete wingwall which is cracked in two areas. Leakage through the dam is occurring along the wall (see Photograph #3). It also appears that the wall has undergone some settlement.

3
CONCRETE WINGWALL AT EAST EMBANKMENT.
SEEPAGE THROUGH WALL WAS
NOTED AT WATERLINE.
